**CALSPAN ON-SITE AIR BAG DEPLOYMENT INVESTIGATION
CALSPAN CASE NO. 94-14
VEHICLE: 1994 OLDSMOBILE NINETY EIGHT REGENCY ELITE
LOCATION: [REDACTED]
CRASH DATE: [REDACTED], 1994**

14. Sponsoring Agency Code	
15. Supplementary Notes On-site investigation of an air bag deployment crash that resulted in multiple fractures to the right hand of the right front passenger of a 1994 Oldsmobile Ninety Eight as she attempted to brace against the air bag module cover flap.

**Selected Color Prints
Calspan Case No. 94-14**

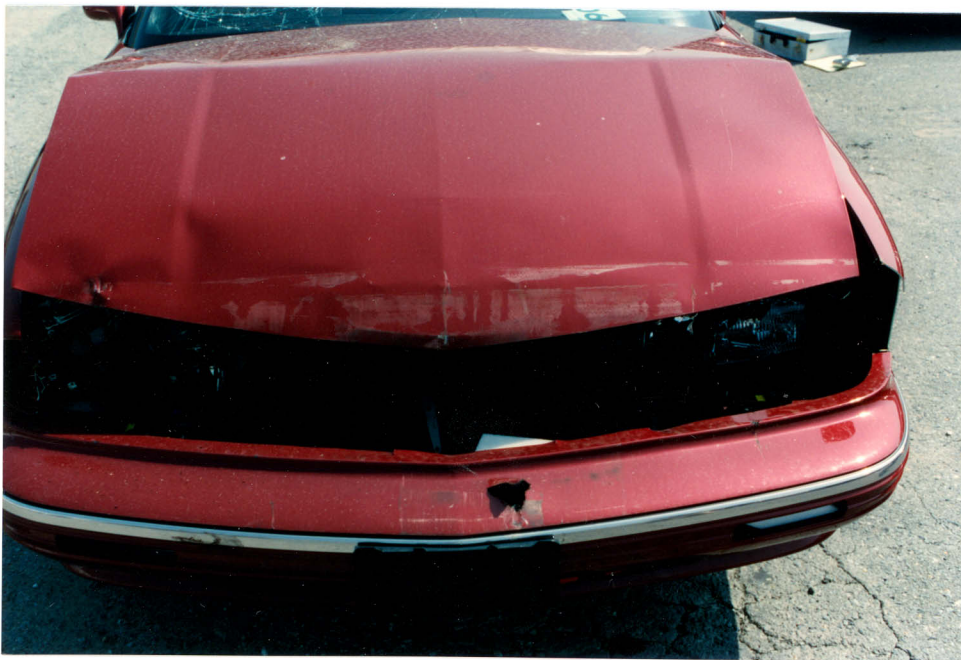
7. Direct contact damage across top surface of bumper fascia and hood.

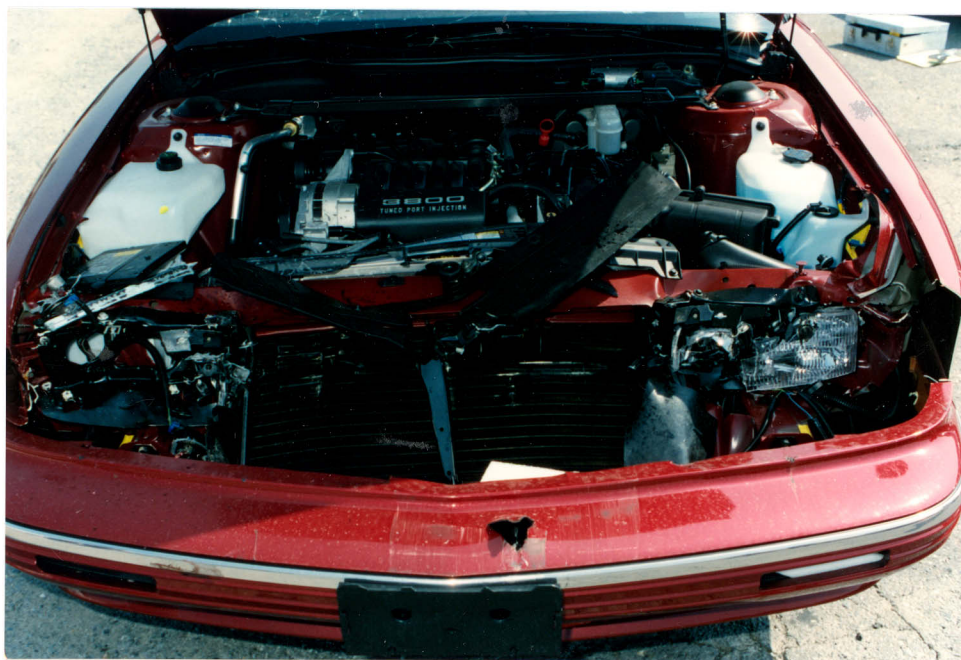
8. Damage across grille and upper radiator support.

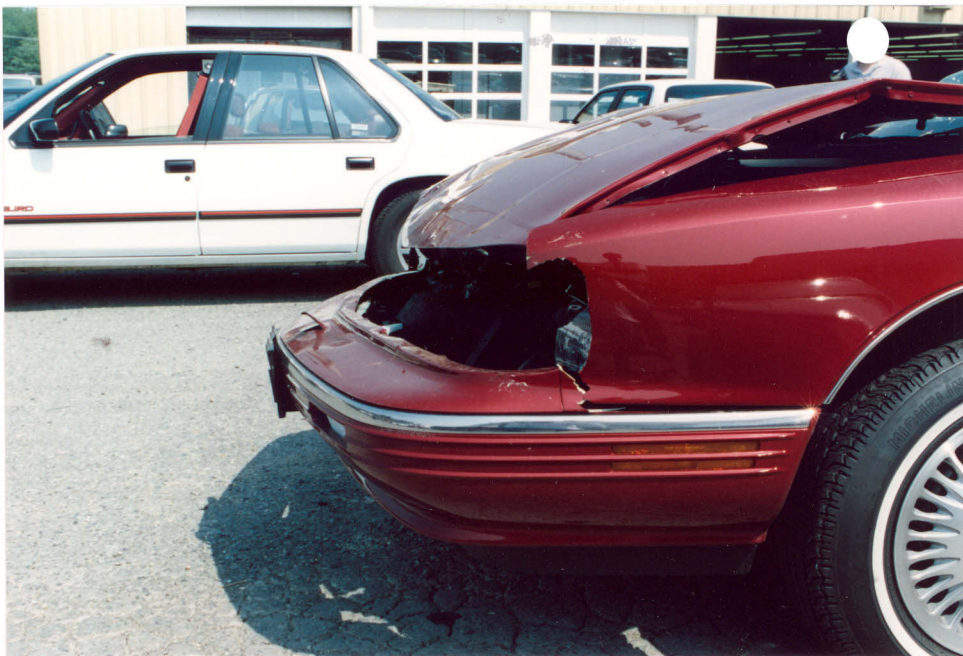
12. Perpendicular view of the hood displacement.

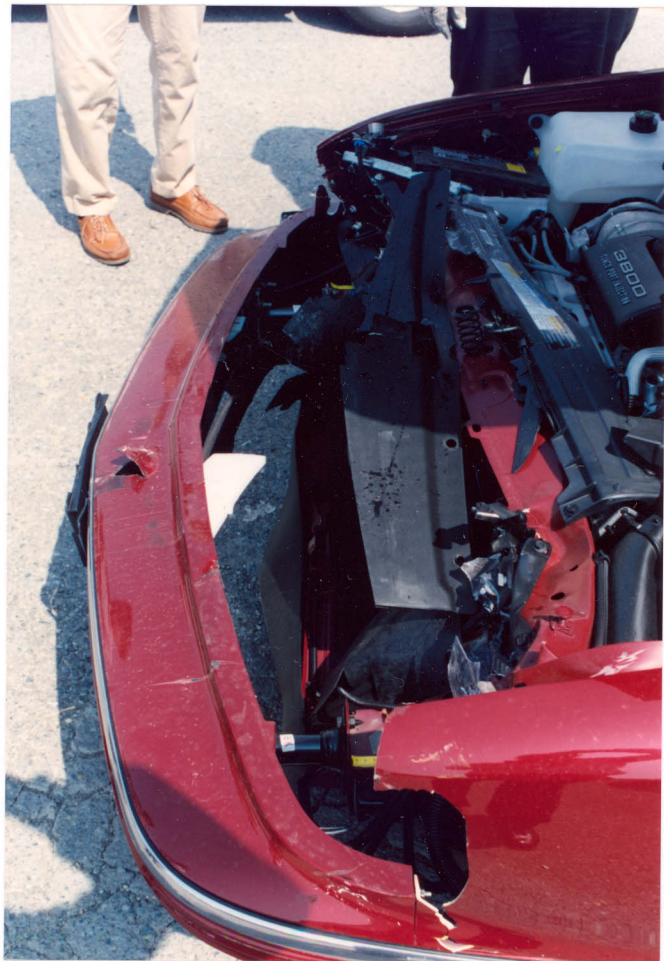
13. Perpendicular view of the crush to the upper radiator support.

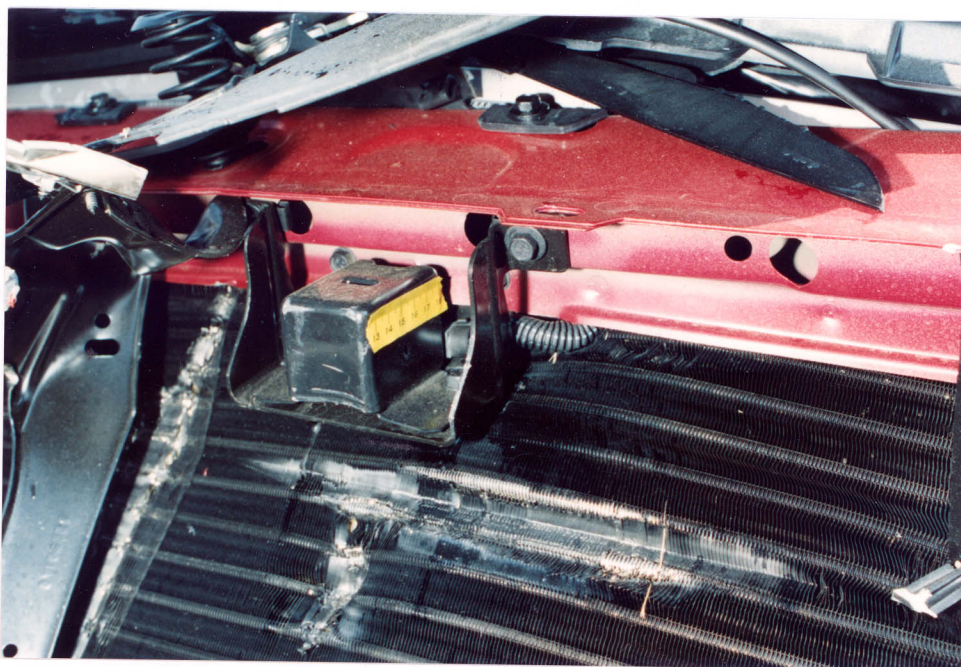
The two outboard discriminating sensors were mounted to the frame rails directly rearward of the bumper EADs (refer to Photograph Nos. 17 and 19). The third discriminating sensor was mounted to the forward side of the radiator support panel, adjacent to the left side of the hood latch assembly. The forward aspect of the center mounted sensor was slightly deformed as a result of the frontal impact (refer to Photograph No. 18), however, the deformation did not appear to have damaged the internal components of the sensor.

18. Contact damage to the leading edge of the center front discriminating sensor.

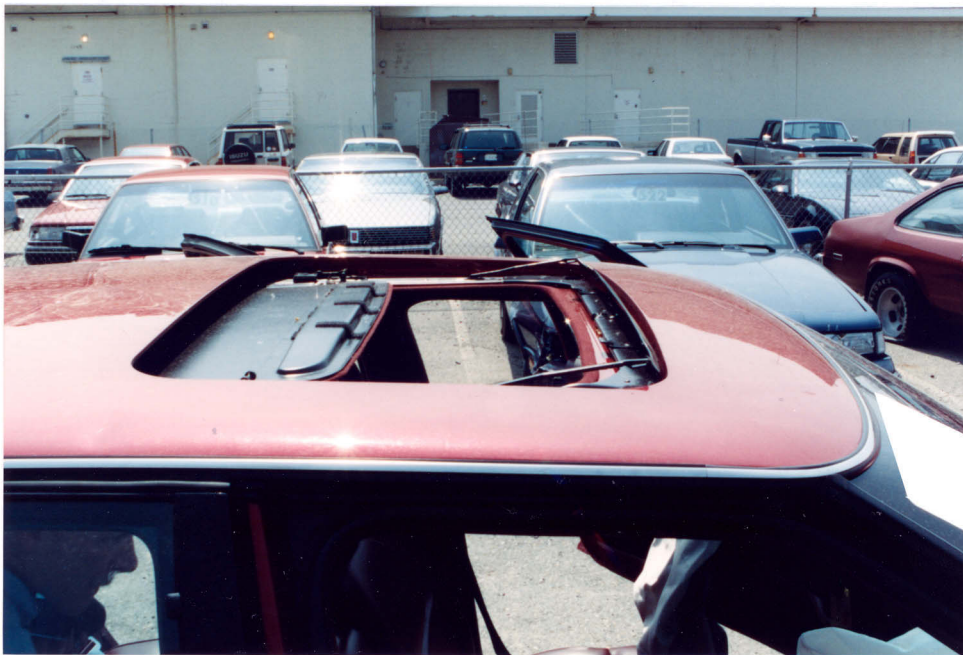
25. Tempered glass sun roof separated from the vehicle.

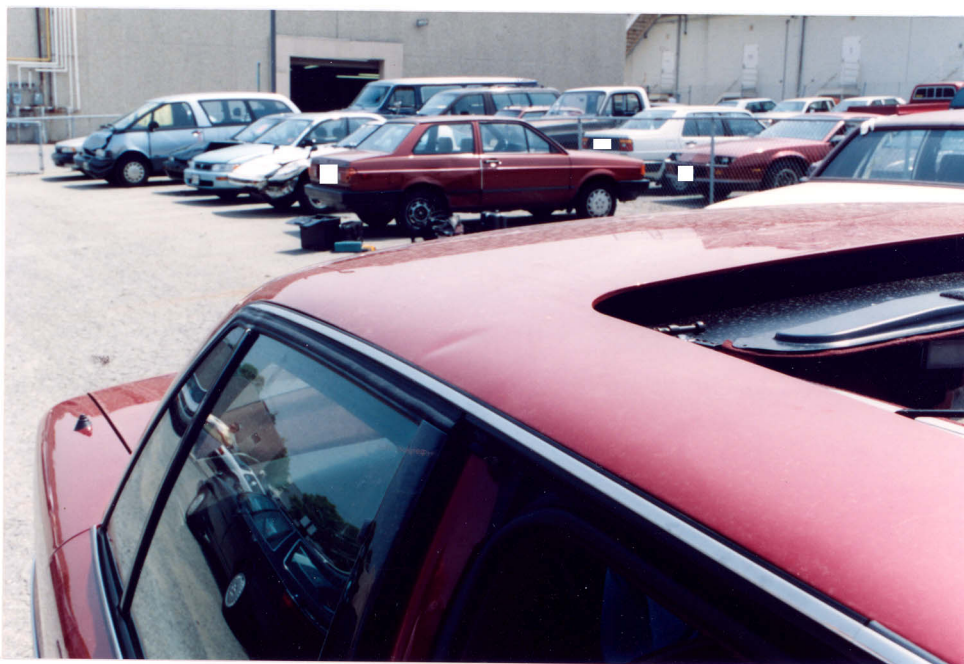
The 1994 Oldsmobile Ninety Eight sustained moderate frontal damage as a result of its front-to-rear impact sequence with the stopped Ford Ranger (vehicle #2). In an attempt to avoid the crash, the driver of the Oldsmobile applied a braking force which compressed the front suspension as the vehicle impacted the rear of the stopped Ford Ranger. The top surface of the front bumper fascia initially impacted then underrode the rear step bumper of the pickup truck. Damage to the fascia consisted of longitudinally oriented abrasions to top surface and a tear located 7.6 cm (3.0") left of the center that resulted from the trailer hitch stud protruding from the center of the rear bumper of the Ford Ranger. The center-mounted license plate frame was cracked as a result of the contact sequence. There was compression of the bumper energy absorbing devices (EADs) and no residual crush at bumper level. Both front bumper EADs remained in their original pre-crash position at 8.6 cm (3.375") in length (refer to Photograph Nos. 15 and 16). As the front bumper of the Oldsmobile underrode the rear bumper of the Ford Ranger, the grille and hood face area engaged against the bumper face and tailgate of the Ford Ranger. The direct contact damage was 140.0 cm (55.1") in length which extended across the entire width of the vehicle at grille level. The contact fractured the plastic grille and headlamp assemblies and deformed the air conditioning condenser, the center mounted air bag discriminating sensor, and the upper radiator support panel. Maximum crush was 25.1 cm (9.875") located at the radiator support panel 38.1 cm (15.0") left of center (refer to Photograph Nos. 13 and 14). The residual crush profile was documented at the upper radiator support level and was as follows: $C_1 = 9.1 \text{ cm (3.6")}$, $C_2 = 24.4 \text{ cm (9.6")}$, $C_3 = 19.7 \text{ cm (7.75")}$, $C_4 = 16.8 \text{ cm (6.6")}$, $C_5 = 14.2 \text{ cm (5.6")}$, $C_6 = 2.3 \text{ cm (0.9")}$. The leading edge of the hood sustained contact damage from engagement with the tailgate of the struck Ford Ranger. The contact damage began 12.1 cm (4.75") inboard of the right corner and extended 134.6 cm (53.0") to the left corner (refer to Photograph No. 7). The tempered glass sunroof separated from the vehicle and was found lying undamaged in the rear seat area of the vehicle. The roof sustained symmetrical areas of deformation directly rearward of the B-pillars on both sides of the vehicle (refer to Photograph Nos. 21 and 26).

26. Induced deformation to the roof at the right B-pillar area.

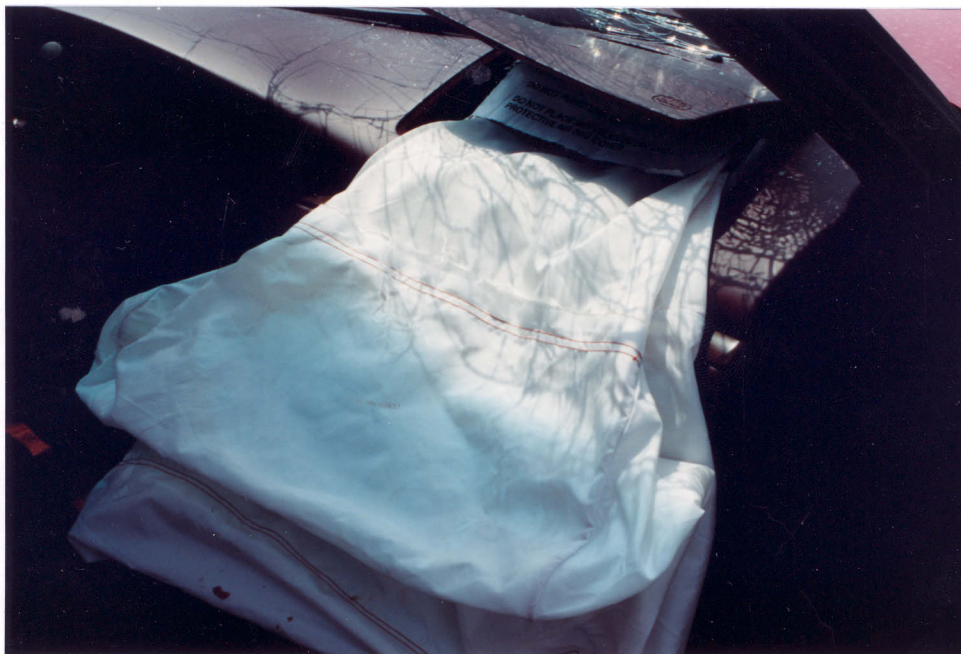
As a result of windshield contact, the module cover flap was abraded over the leading edge and front third area of the flap. In addition to the abrasions, the right third area of the flap was deformed in a downward direction 1.3 cm (0.5"), probably due to the contact with the curvature of the windshield. The expanding passenger side air bag probably contacted the interior rear view mirror and displaced the right side of the mirror in an upward direction. The trim panel at the trailing edge of the instrument panel adjacent to the windshield was displaced forward and upward from deployment of the passenger air bag module cover flap (refer to Photograph No. 41). The upper surface of the passenger side air bag exhibited burgundy vinyl transfer marks which resulted from expansion of the bag against the internal surface of the module cover flap. Within the vehicle were numerous white powder transfers that were associated with the deployment. A small white powder transfer was located on the vinyl trim panel at the apex of the B-pillar and the roof side rail. The same substance was also noted on the leading edge of the stowed right sunvisor at 43.8-47.0 cm (17.25-18.5") right of the vehicle's centerline. The visor also had a depression located 41.9-46.4 cm (16.5- 18.25") right of center

40. Passenger side air bag module cover flap.

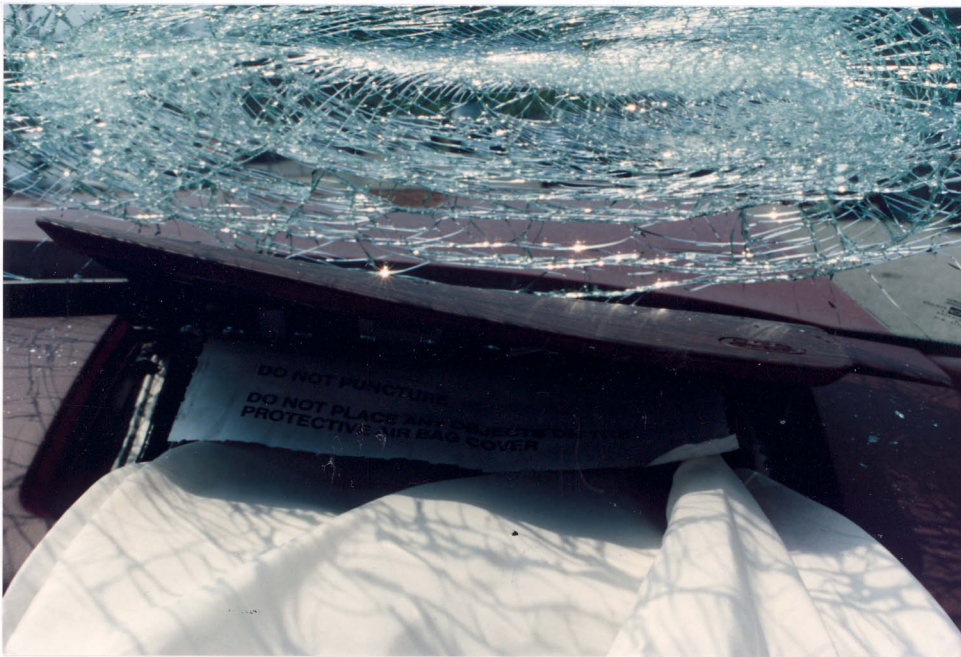
At impact with the Ford Ranger pickup truck, the supplemental driver and passenger side air bag system deployed. The leading edge of the passenger side air bag module cover flap impacted her right third through fifth fingers which resulted in comminuted fractures of the distal right third, fourth, and fifth metacarpals with displacement to the right, comminuted intra-articular fractures of the middle phalanx of the right fifth digit and distal phalanx of the fourth digit, and open lacerations of the volar aspect of the right fourth and fifth digits. There was no evidence of passenger hand to the instrument panel or module cover flap. The cover flap contact in combination with the deploying air bag, displaced her hand in an upward and rearward direction. It should be noted that there was no hand contact with the windshield which was fractured by the cover flap. Numerous whitish -type transfers were noted to the headliner and side rail trim within the vehicle. Although none of these transfers appeared to be tissue, the transfers were probably residue that resulted from deployment of the SRS.

41. Leading edge of the module cover flap.

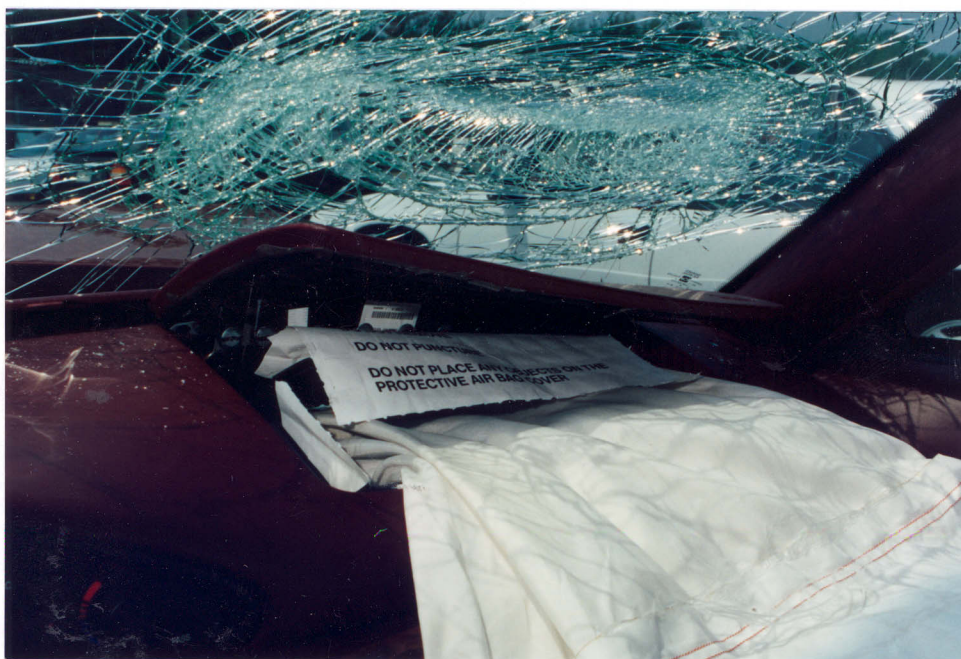
The rigid cover flap impacted and fractured the laminated windshield during deployment. The cover flap sustained 1.3 cm (0.5") of downward deflection at the right third sector that was due to contact with the contoured windshield. A thin sheet of Tyvek-like material was manufactured into the module assembly and was positioned between the interior surface of the module and cover flap which acted as a protective liner for the folded air bag (refer to Photograph No. 42). A bar coded label was affixed to the right side of the passenger side air bag module assembly which identified the unit with the following alpha-numeric sequence:

In addition to the DERM readout, the General Motors representative indicated that the passenger side air bag module cover flap typically does not impact the windshield as it did in this crash related deployment. He noted that when ambient temperatures exceed 21 degrees C (70 degrees F), the gas generators have a tendency to produce more gas, therefore resulting in a more aggressive deployment. This aggressive deployment probably resulted in cover flap contact with the windshield. At the time of the crash, the ambient temperature was approximately 24 degrees C (mid 70's degrees F). The Oldsmobile was apparently parked for an unknown period of time prior to the crash which probably resulted in an interior temperature which exceeded the ambient temperature.

42. Module flap and resultant windshield contact damage.

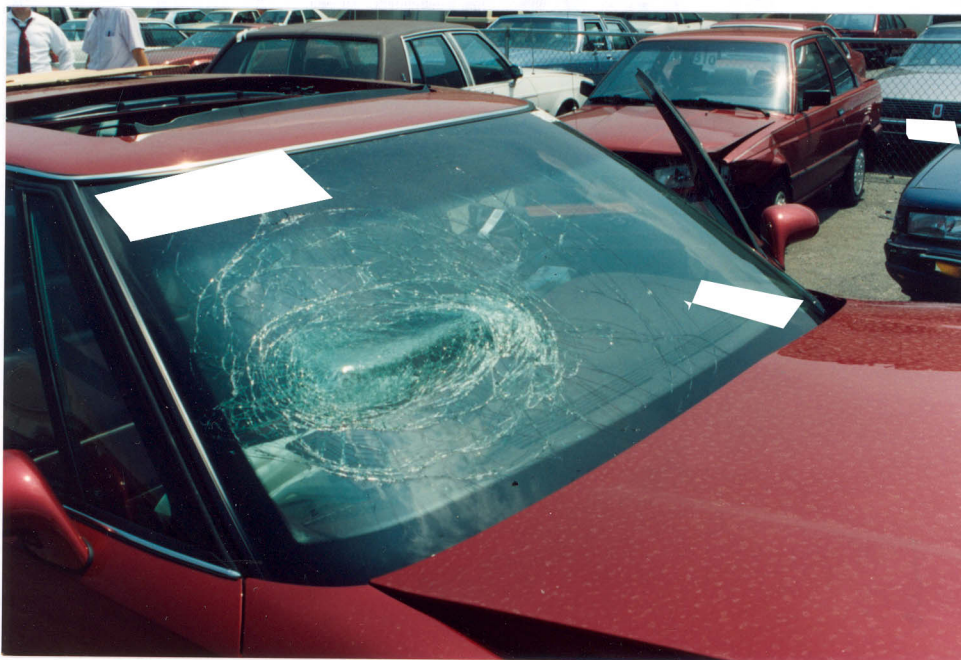
43. Exterior view of the windshield damage.

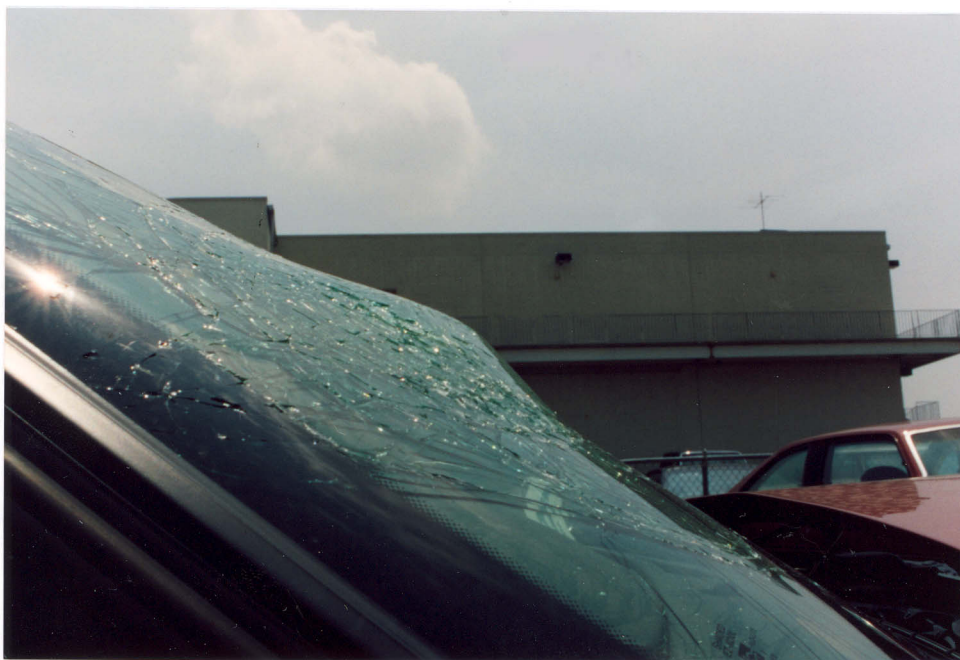
44. Perpendicular view showing the outward displacement of the windshield.

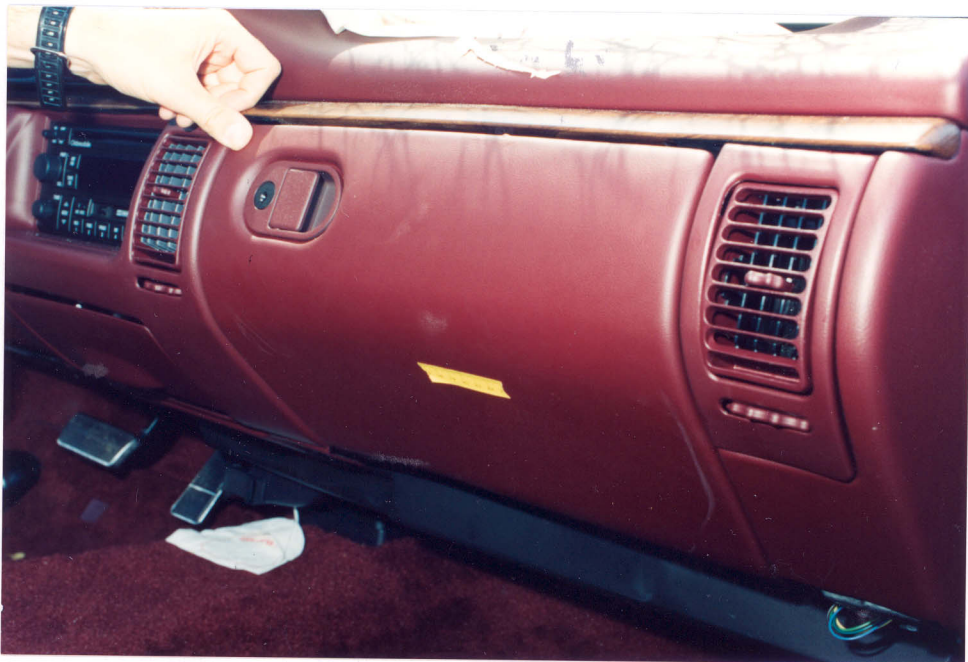
As a result of the deployment of the passenger side air bag, the glove box door opened and probably impacted the passenger's knee and or leg. A scuff with a small diameter gouge was noted to the top edge of the door with a body fluid stain (blood) adjacent to the gouge. There were no injuries reported to the lower extremities of the passenger, therefore the blood stain on the glove box door probably occurred from the hand post-crash. She came to rest in an upright posture in the passenger seat.

46. Possible knee scuff to the glove box door.

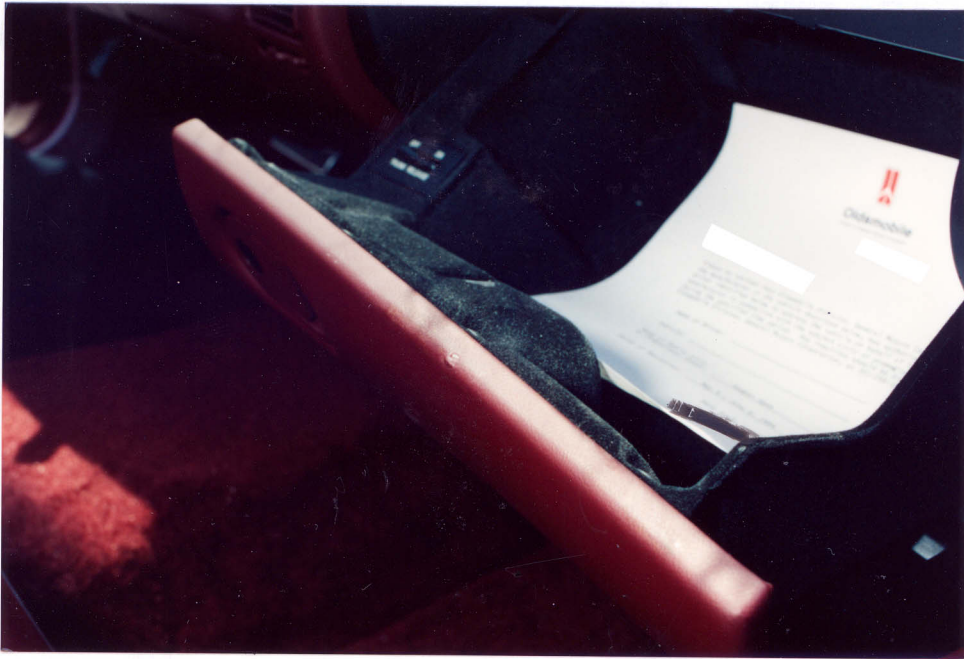
which probably resulted from contact by the volar aspect of the passenger's right hand. A vertically oriented 3.8 cm (1.5") white powder-type scuff was located on the apex of the right mid A-pillar. Another white powder-type mark was located on the leading edge of the passenger roof assist grip (refer to Photograph No. 51). A white powder transfer mark was noted on the headliner adjacent to the B-pillar 10.8-13.3 cm (4.25-5.25") inboard of the side rail (refer to Photograph No. 52). The lower surface of the passenger side air bag exhibited several 1.9 cm (0.75") body fluid (blood) stains which probably occurred post-event as the passenger remained in the vehicle and the bag deflated. The glove box door was found fully open and would not latch, although it was not deformed. A possible knee scuff was located on the glove box door 19.7-22.5 cm (7.75-8.875") right of the left edge and 12.7-14.6 cm (5.0-5.75") below from the mid panel/upper panel juncture (refer to Photograph No. 46). The vinyl fabric at the top edge of the glove box door was gouged 24.1-24.4 cm (9.5-9.625") right of the left edge (refer to Photograph No. 47). Body fluid was present around gouge.

47. Gouge to the top edge of the glove box door.

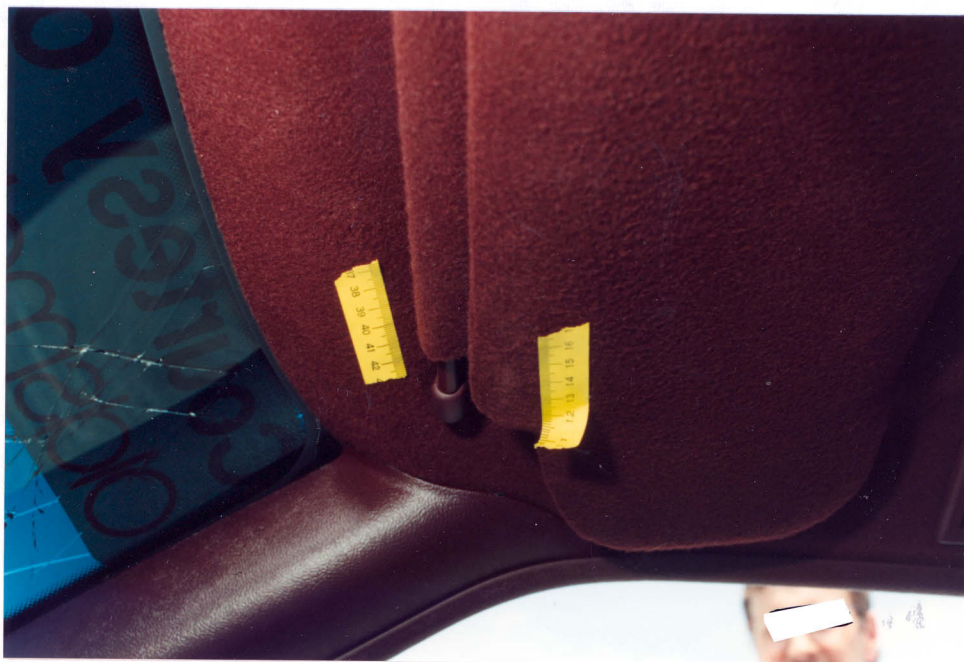
49. White powder transfer on the leading edge of the right sun visor.

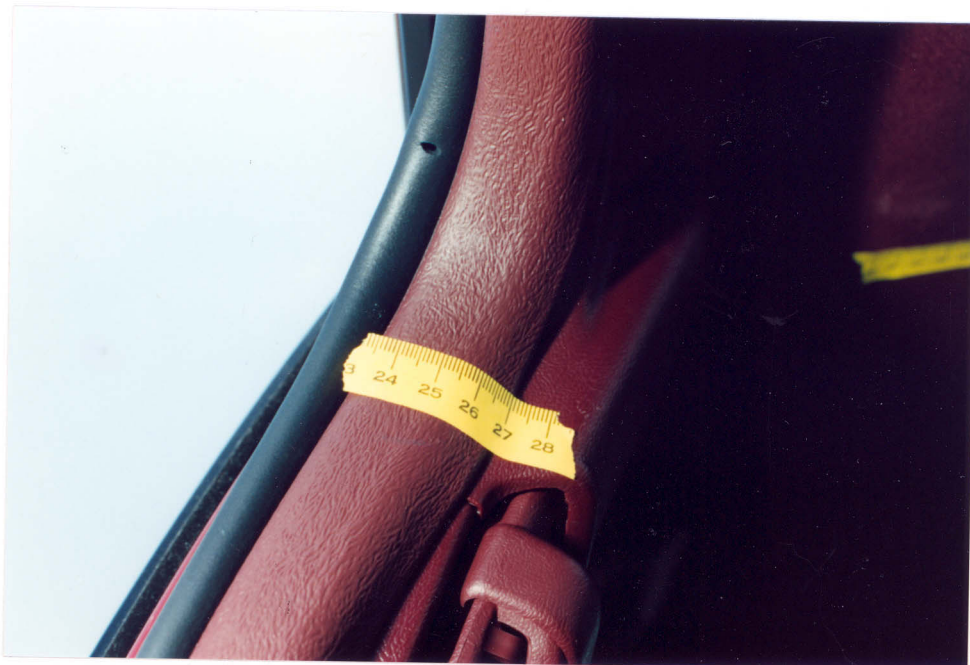
50. White powder transfer at the apex of the right B-pillar/side rail juncture.

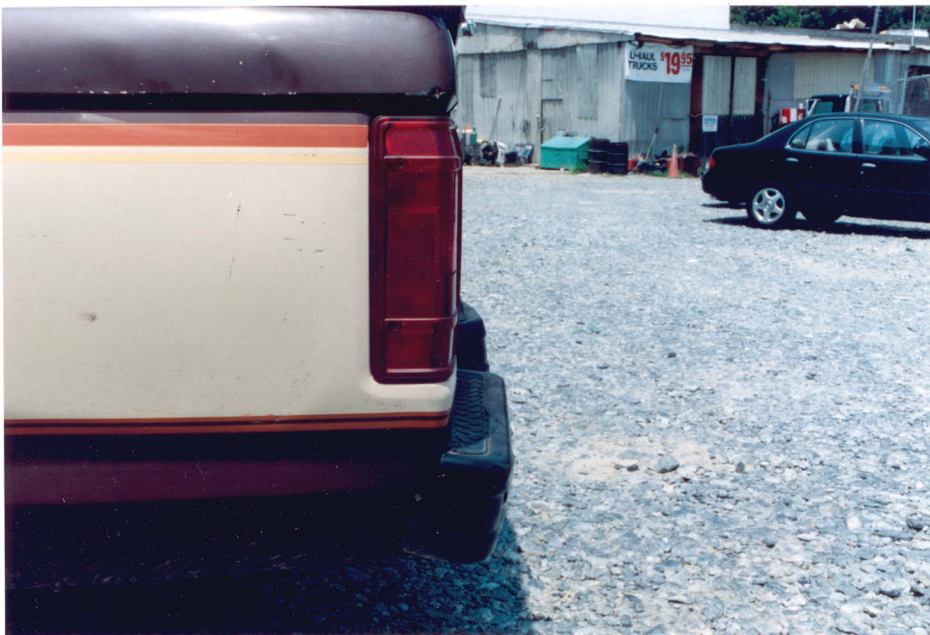
56. Perpendicular view of bumper crush at the left rear corner.

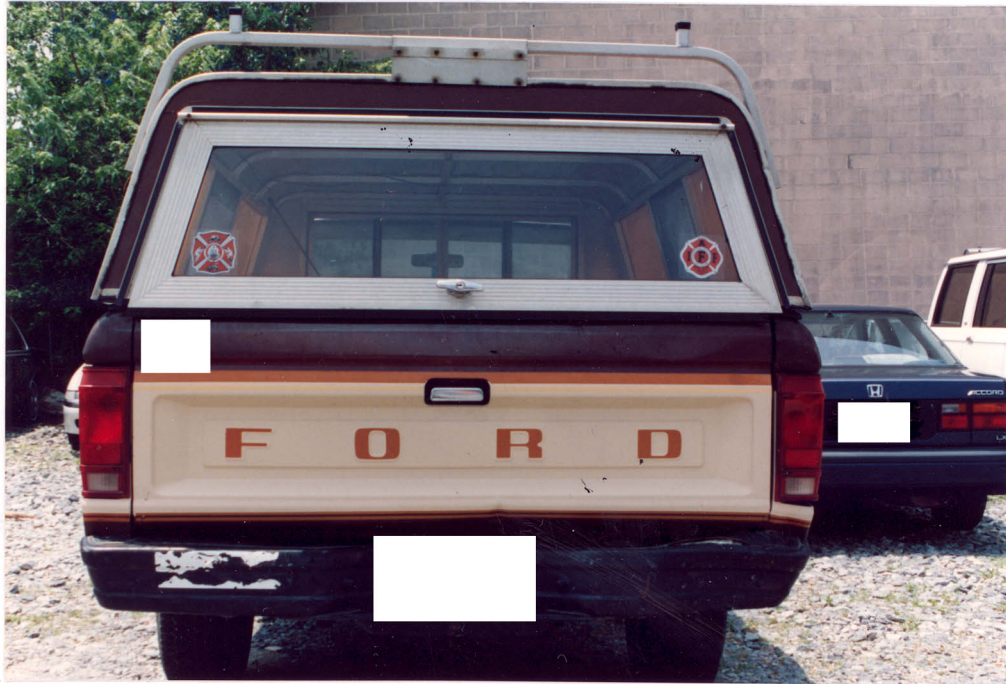
The 1983 Ford Ranger sustained full-width direct contact damage of 153.0 cm (60.25") to the lower portion of the rear bumper. The rear bumper was an original equipment manufacture (OEM) type step bumper with a ball hitch bolted to the mid point. Maximum crush was 7.3 cm (2.9") located on the lower right corner area. The crush profile was as follows: $C_1=5.1$ cm (2.0"), $C_2=2.8$ cm (1.1"), $C_3=1.5$ cm (0.6"), $C_4=1.9$ cm (0.75"), $C_5=5.1$ cm (2.0"), $C_6=7.3$ cm (2.9"). The vehicle damage profile is documented in Photograph Nos. 55- 58. The hood of the Oldsmobile engaged against the lower tailgate of the Ford Ranger, however, there was no contact damage to the tailgate. Paint transfers were noted to the hood face of the Oldsmobile from tailgate contact. Minor right frontal damage resulted to the Ford Ranger from its subsequent impact sequence with the stopped Nissan Pathfinder (vehicle #3). The damage consisted of bumper deformation at the right corner, right headlight and grille damage, and right front fender crush.

57. Rear view of the distributed direct contact damage.

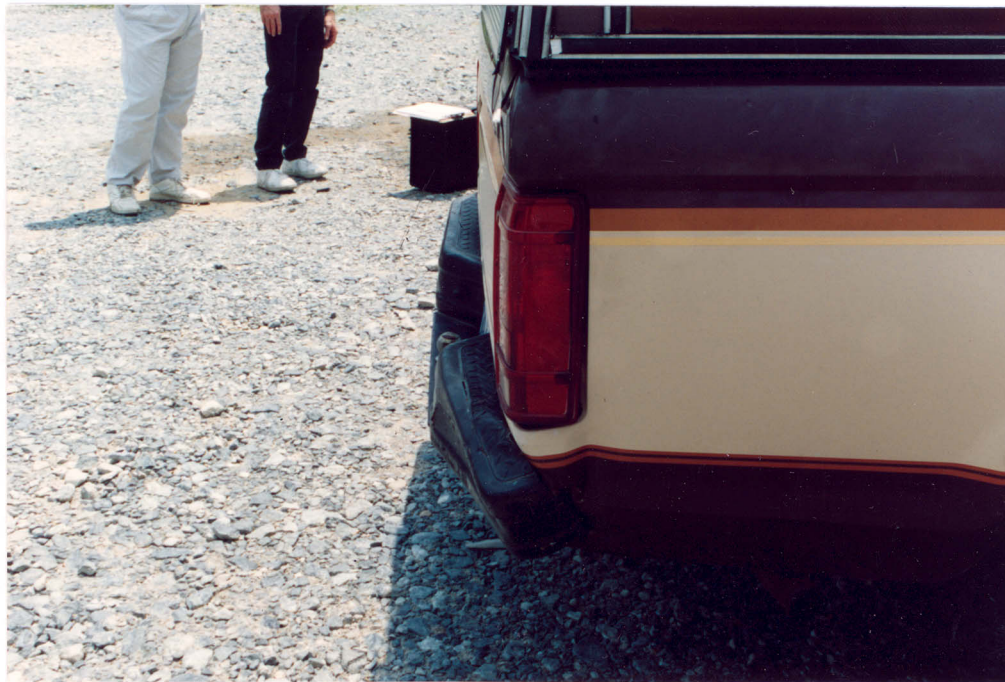
58. Perpendicular view of the right rear corner showing the extent of crush.

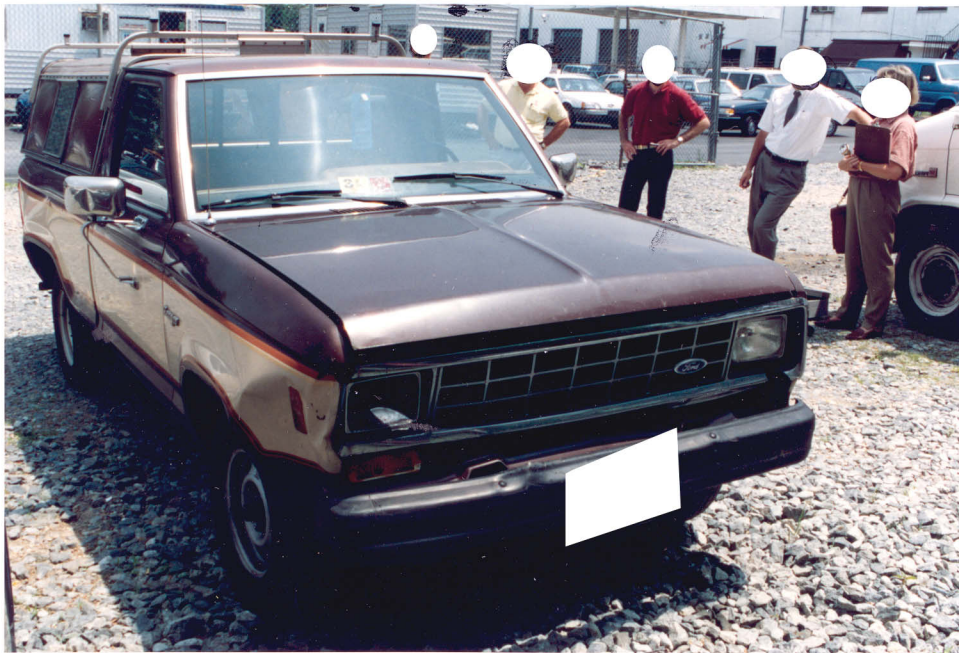
The impact displaced the Ford Ranger pickup truck in a forward direction where it impact the stopped 1988 Nissan Pathfinder (vehicle #3). The subsequent impact sequence resulted in impact forces of 12 o'clock and 6 o'clock for the Ford and Nissan respectively. Frontal damage to the Ford Ranger consisted of deformation to the right side bumper, headlamp, grille, and right front fender. The rear of the Nissan Pathfinder sustained minor damage.

60. Subsequent frontal damage that resulted from contact with vehicle #3.
